**National Highway
Traffic Safety
Administration**

Case Vehicle (A): 1999 Dodge
 Type: Dakota Sport, 4x2 regular cab pickup
 Driver: 61-year-old female
 CDC: 11-FDEW-3

Vehicle (B): 1978 International
 Type: COF Transtar 6x4 farm truck
 Driver: 32-year-old male
 CDC: 99-0000-0

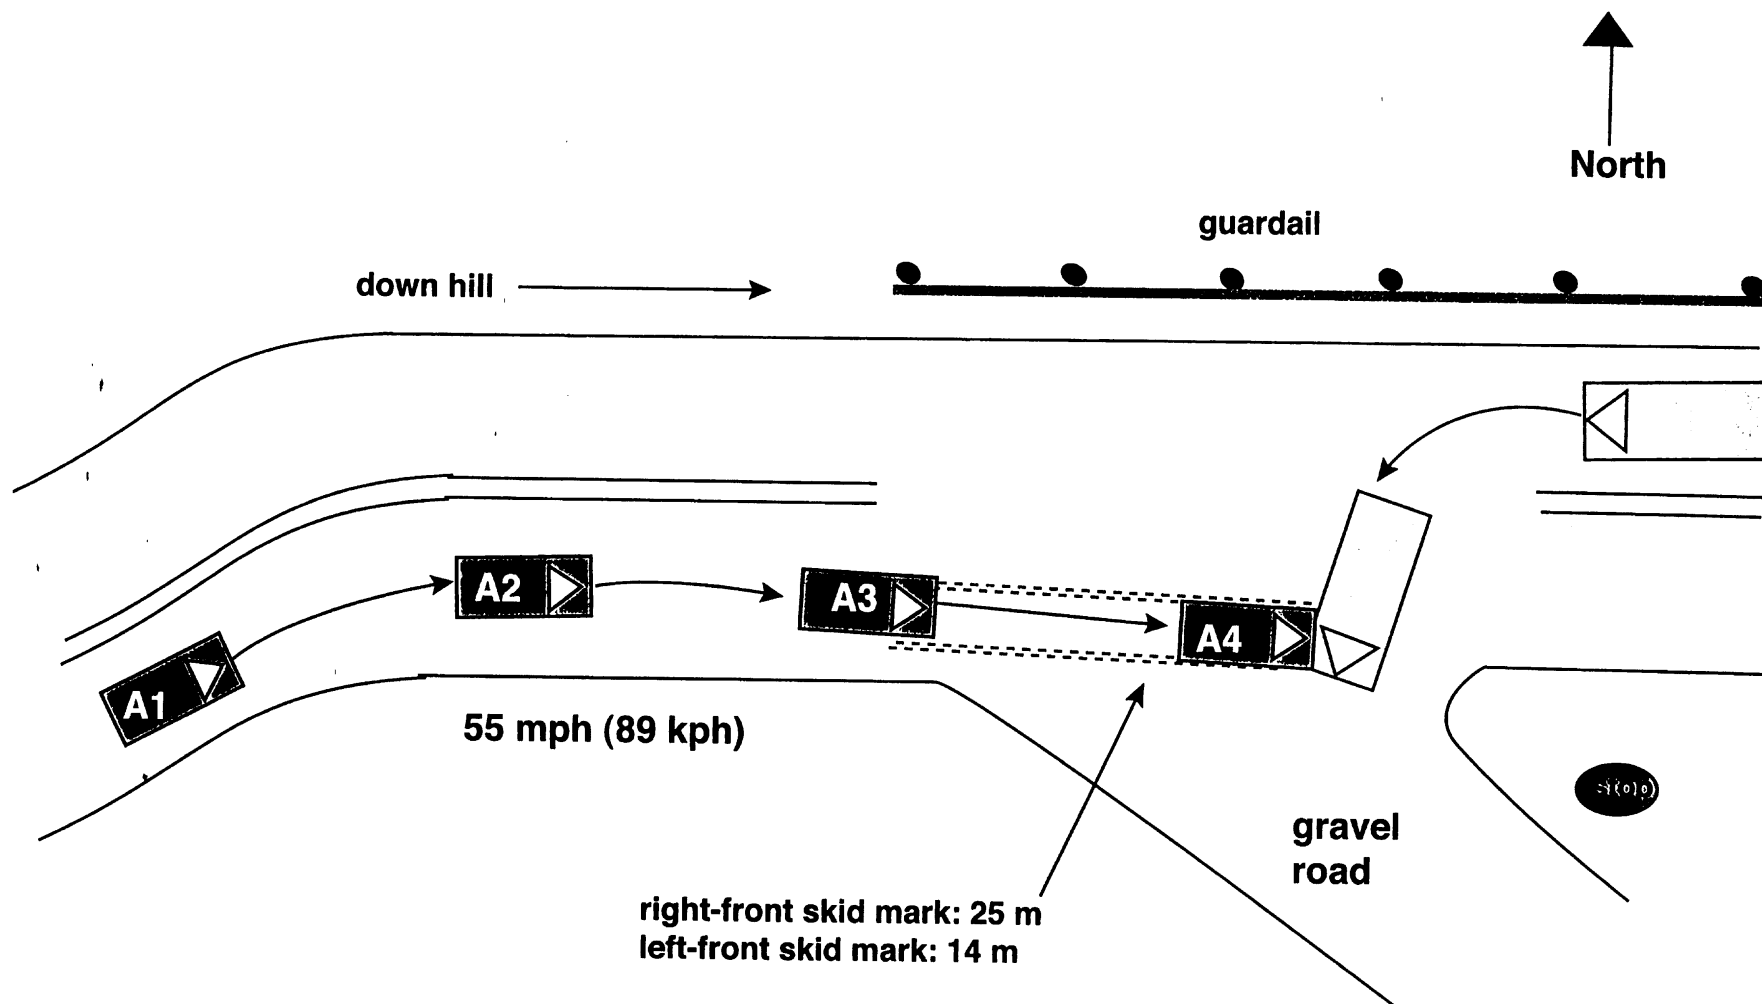
ACCIDENT SCHEMATIC

ACCIDENT DESCRIPTION: CASE VEHICLE (A) WAS TRAVELING
EAST AT AN UNKNOWN SPEED. VEHICLE (B) WAS
TRAVELING WEST. AS CASE VEHICLE (A) WAS

TRAVELING PAST A 3-LGE INTERSECTION, VEHICLE (B) MADE A LEFT TURN. THE
DRIVER OF CASE VEHICLE (A) BRAKED, BUT WAS UNABLE TO AVOID STRIKING THE
RIGHT SIDE OF VEHICLE (B)

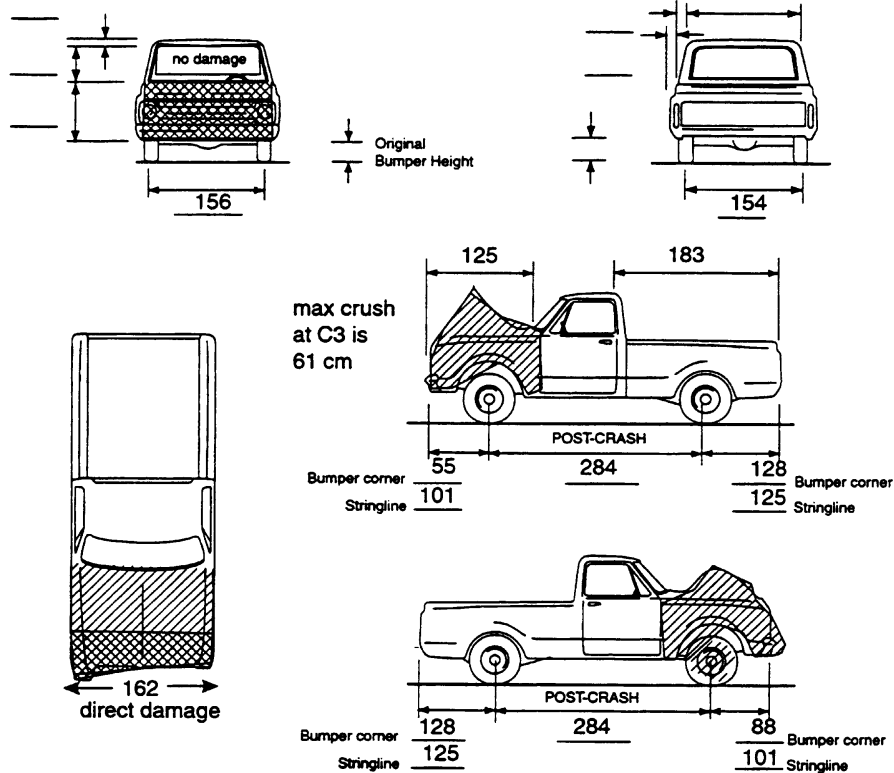
VEHICLE DAMAGE

(Slides 7, 8) The direct damage to case vehicle (A) began at the left-front bumper corner and extended 162 cm across the entire front end. The maximum crush was 61 cm to the center portion of the front bumper.

Direct Damage Length (DDL) 162 cm

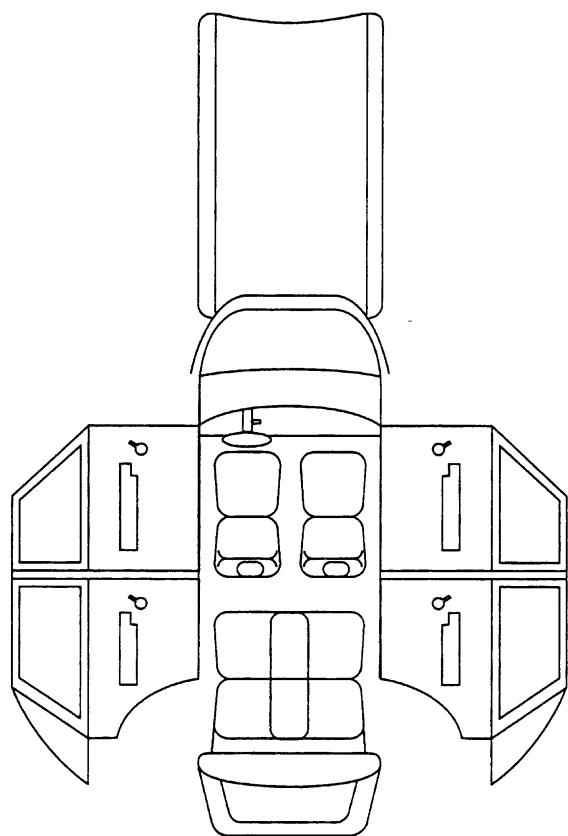
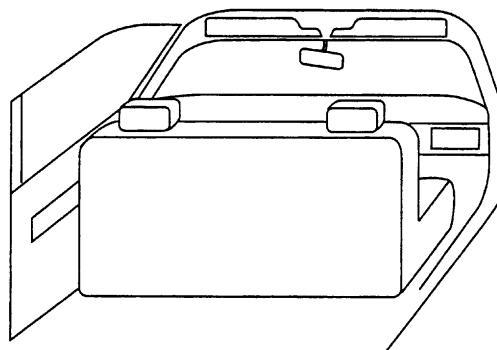
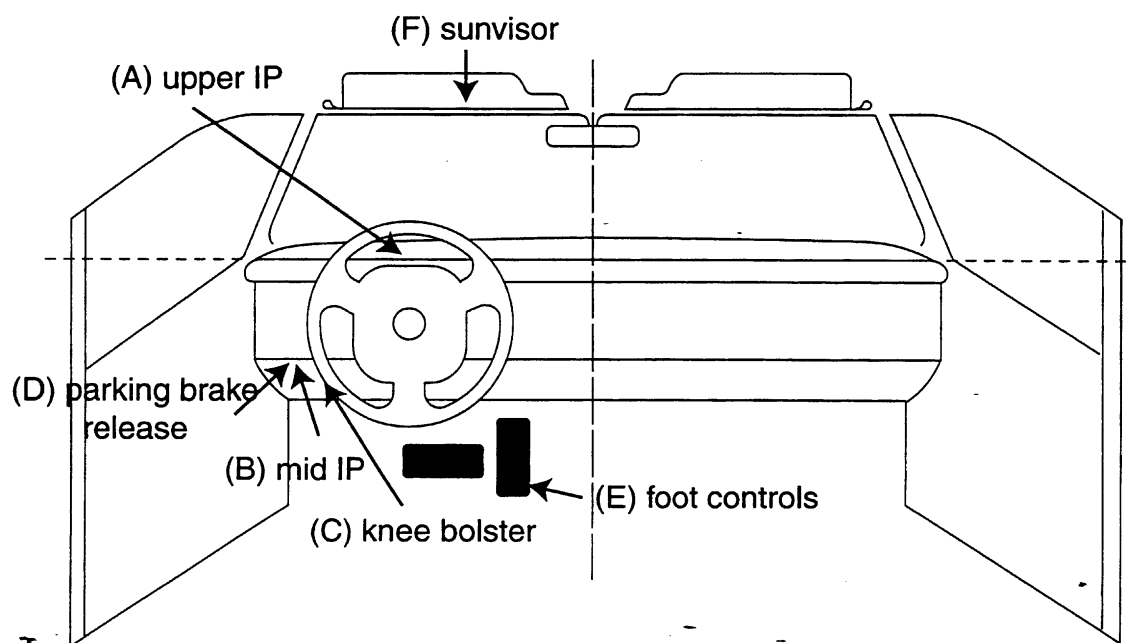
VEHICLE OCCUPANT CONTACT DIAGRAM

Contact	Interior Component Contacted	Occupant No. if Known	Body Region if Known	Supporting Physical Evidence	Confidence Level of Contact Point
A	Upper IP	1	Hand	Skin	2
B	Mid IP	1	Hand	Damage to panel	2
C	Knee bolster	1	Knee	Scuff	1
D	Parking brake release	1	Knee/leg	Damage	1
E	Foot controls	1	Feet	Gas and brake pedal bent to left	1
F	Sunvisor	1	Head	Bent, scuff, blood	1
G					
H

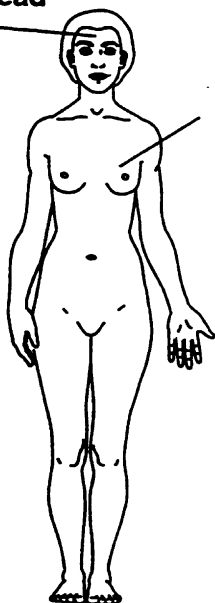
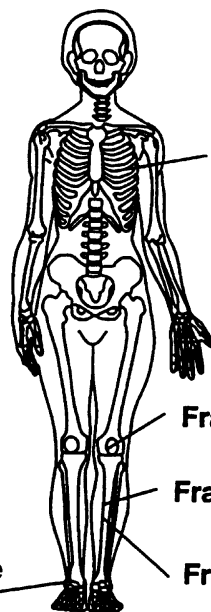
INDICATE LOCATION OF INJURIES.

Contusion, forehead
(1)

Left lung laceration
with pneumothorax
(3)

Two left rib
fractures
(2)

Fracture, left patella
(2)

Fracture, left fibula
(2)

Fracture, right ankle
(2)

Fracture, left tibia
(2)
